HERTFORD ST ANDREW – FOUL DRAIN REPAIRS – STATEMENT OF NEED

HERTFORD ST ANDREW – DRAIN REPAIRS – APRIL 2025

Drainage Investigation Report

183751.1.UCC

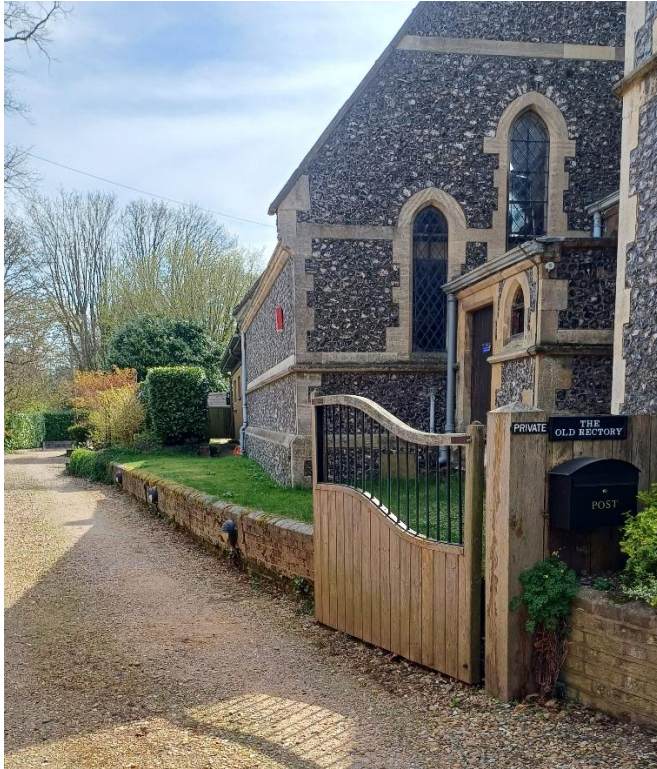
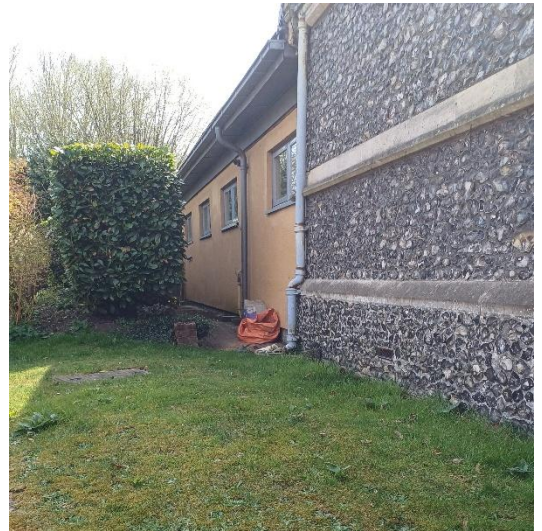
LOCATION OF DAMAGED DRAIN PIPE

Tithe Lane, now a private drive, beside the church and St Andrew's Centre from St Andrew Street towards the Old Rectory. Damaged drain by the orange bag on the grassy bank (Church land).

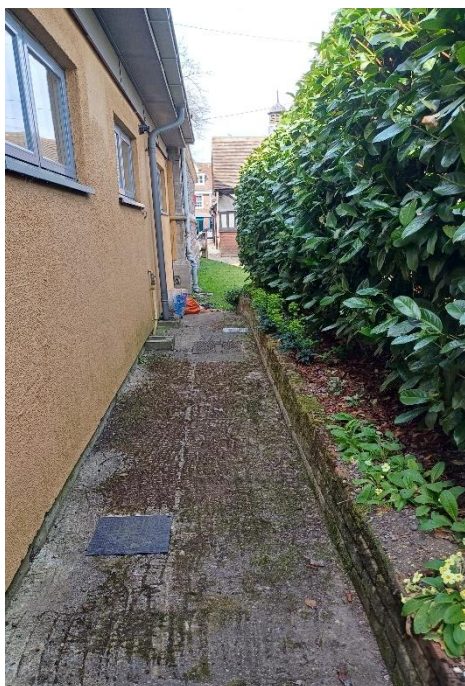
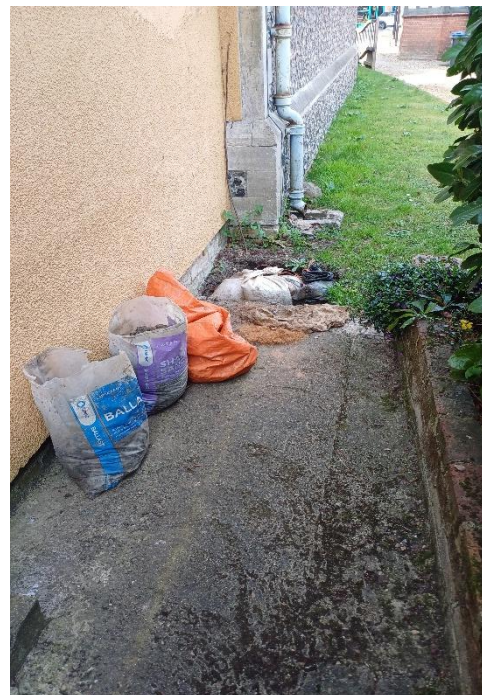
The drain has now been cleared of soil blockage and is flowing well. The hole in it is covered by sandbags so the repair is not extremely urgent but needs to be done soon as the pathway behind the Centre, although rarely used, is a fire escape and, as can be seen in the photos, the sandbags are a trip hazard. Also, any open foul drain is a health hazard.

Below – path behind Centre looking towards St Andrew Street up Tithe Lane. Broken drain by orange bag covered by white sandbags.

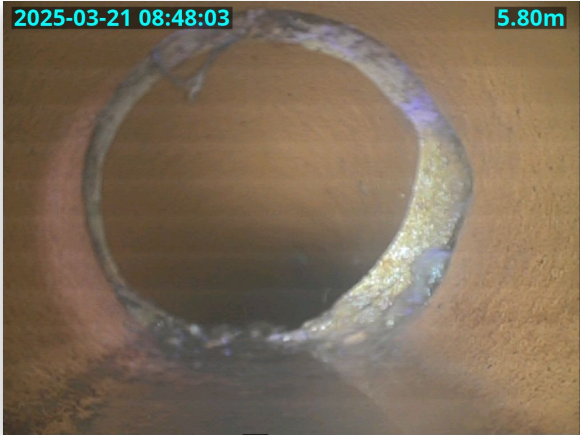
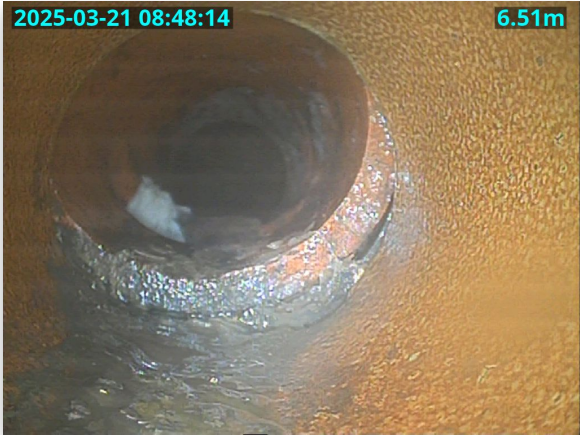
Drain Survey	<p>Upon attending site we carried out a CCTV survey of the below ground drainage system, our findings of which are as follows:</p> <p>Our survey of line 1, from MH1 (manhole 1) downstream towards buried MH2, revealed large joint displacements within the line. The defects identified are affecting the function of the below ground drainage system.</p>
Claim Accepted	<p>The cause of damage resulting in the joint displacements is consistent with an external force being applied and in this case, we conclude that this is due to ground movement applying force or loading to the material around the pipe which have been sufficient to cause the damage in sections of the drain. The damage should therefore be considered accidental.</p> <p>The claim for accidental damage to underground services should therefore be accepted as there are insurable defects to the below ground drainage system.</p>

Fig 1.1: Line 1, joint displacement	Fig 1.2: Line 1, joint displacement

Claim Withdrawn - Less Than Excess	<p>It is recommended that the following repairs are carried out to restore full function to the system:</p> <p>Line 1 Excavate and replace 1.5m of 100mm pipework directly upstream of buried MH2 at a depth no greater than 1.0m through soil.</p> <p>The recommended schedule of works is however less than the customer's policy excess amount of £500.00, Auger can however undertake these works privately for the customer at the cost of £467.23 including VAT if the customer wishes.</p>
------------------------------------	---

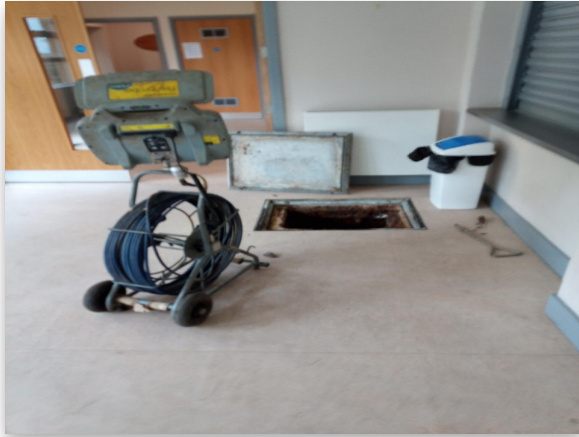
Fig 2.1: Location of MH1

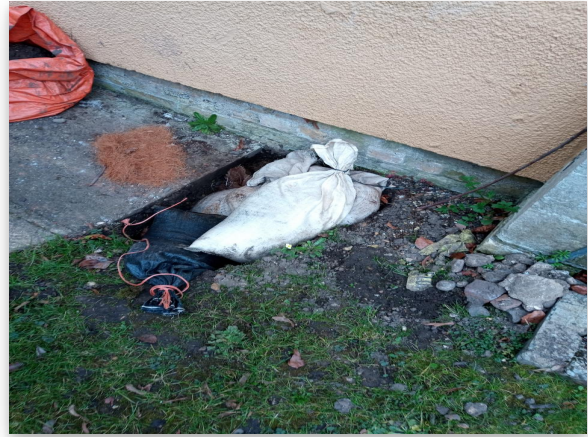
Fig 2.2: Route of Line 1

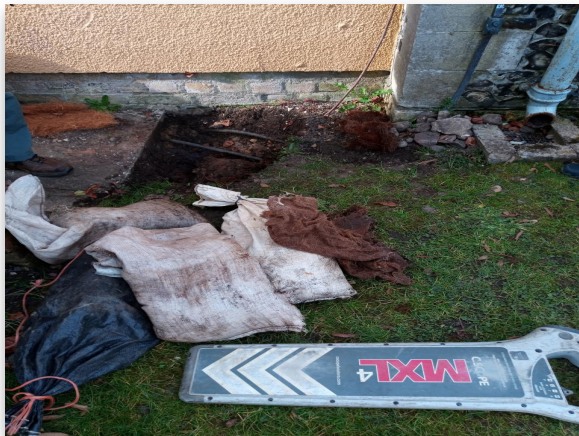
Fig 2.3: Route of Line 1

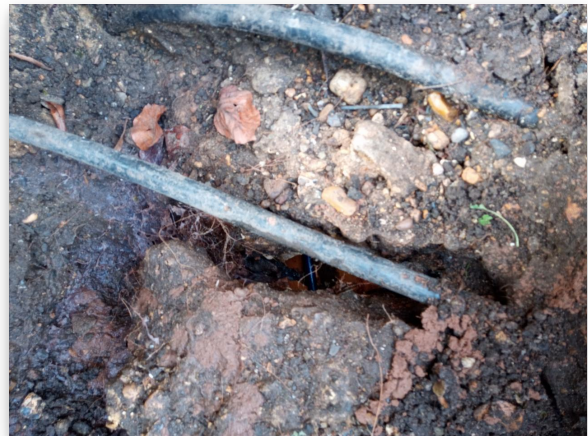
Fig 2.4: Pipework exposed within excavation
