HERTFORD ST ANDREW – FOUL DRAIN REPAIRS – STATEMENT OF NEED

HERTFORD ST ANDREW – DRAIN REPAIRS – APRIL 2025

Drainage Investigation Report

183751.1.UCC

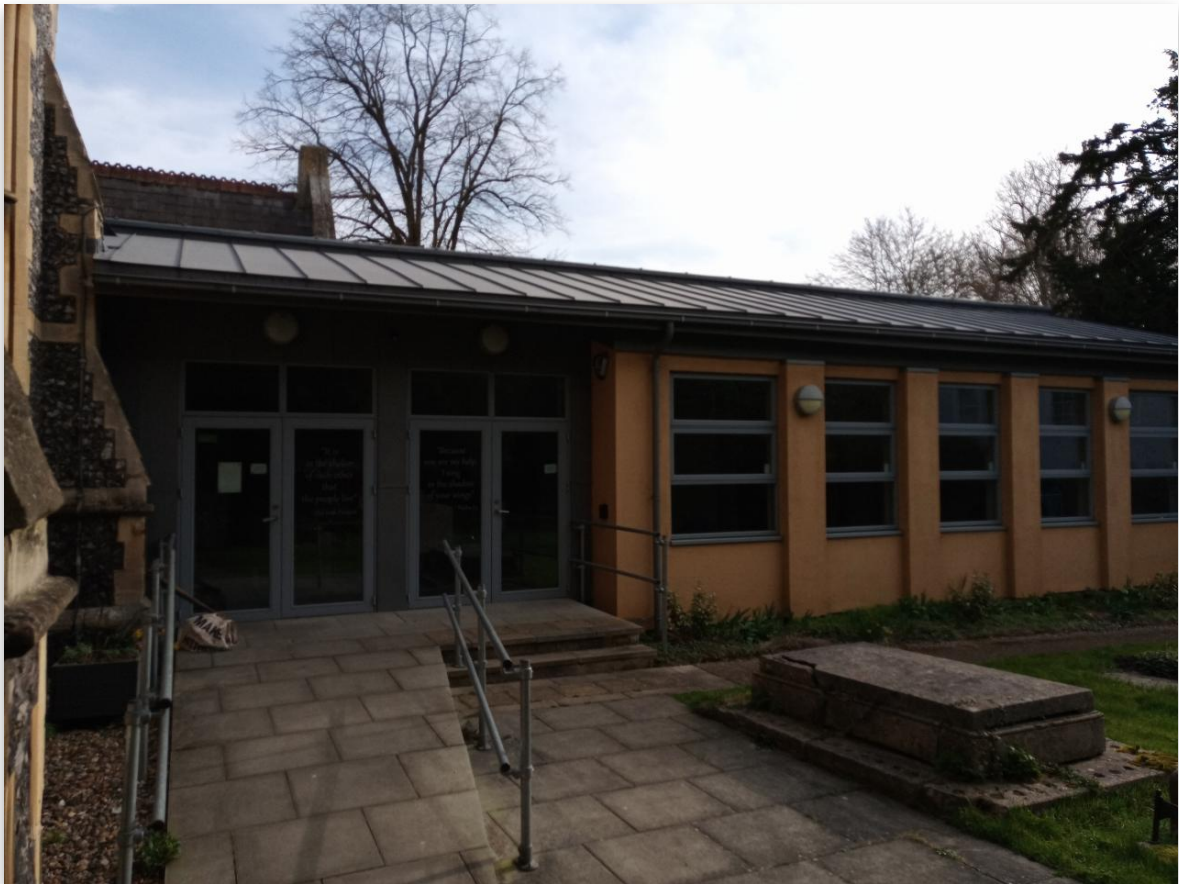
Drain Survey	<p>Upon attending site we carried out a CCTV survey of the below ground drainage system, our findings of which are as follows:</p> <p>Our survey of line 1, from MH1 (manhole 1) downstream towards buried MH2, revealed large joint displacements within the line. The defects identified are affecting the function of the below ground drainage system.</p>
Claim Accepted	<p>The cause of damage resulting in the joint displacements is consistent with an external force being applied and in this case, we conclude that this is due to ground movement applying force or loading to the material around the pipe which have been sufficient to cause the damage in sections of the drain. The damage should therefore be considered accidental.</p> <p>The claim for accidental damage to underground services should therefore be accepted as there are insurable defects to the below ground drainage system.</p>

Claim Withdrawn - Less Than Excess	<p>It is recommended that the following repairs are carried out to restore full function to the system:</p> <p>Line 1 Excavate and replace 1.5m of 100mm pipework directly upstream of buried MH2 at a depth no greater than 1.0m through soil.</p> <p>The recommended schedule of works is however less than the customer's policy excess amount of £500.00, Auger can however undertake these works privately for the customer at the cost of £467.23 including VAT if the customer wishes.</p>
------------------------------------	---
