## **HERTFORD ST ANDREW – STATEMENT OF NEED**

## **OFFICE WINDOW REPAIRS**

VAT REGISTRATION No. 759743674 Partners T. Lankester, E. Lankester, V. Lankester. R. Lankester HERTFORD ST ANDREW – WINDOW REPAIR Photo showing all five windows Left to right 1,2,3, then round corner 4,5

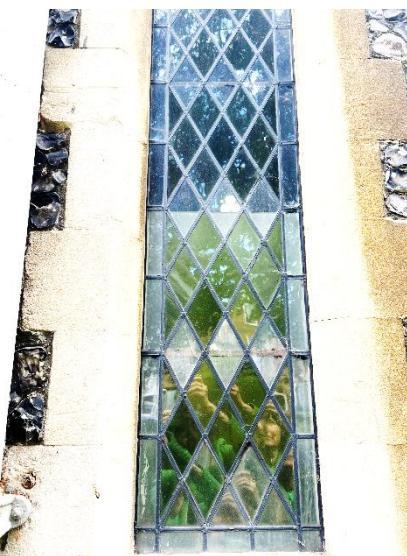
Above - Window 1

Several of the windows of the five which surround the church office have cracked quarries, through wear and tear over the years.

Lankesters have recommended that the bottom 2/3<sup>rd</sup> of Window 4 be removed for complete repair of the lead and glass and that 10 further quarries of glass be replaced in the existing lead in situ in other windows.

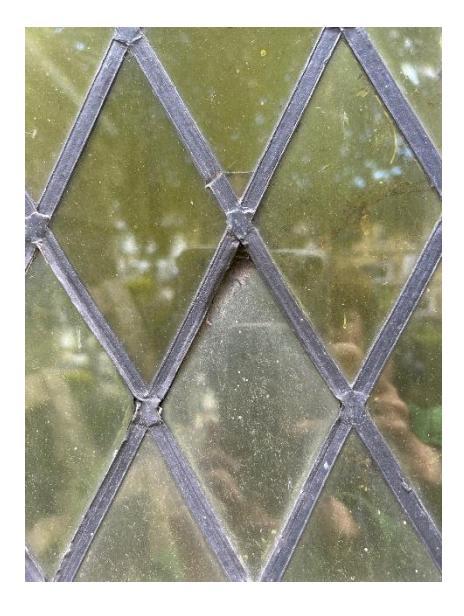
Above – Window 1 bent leads

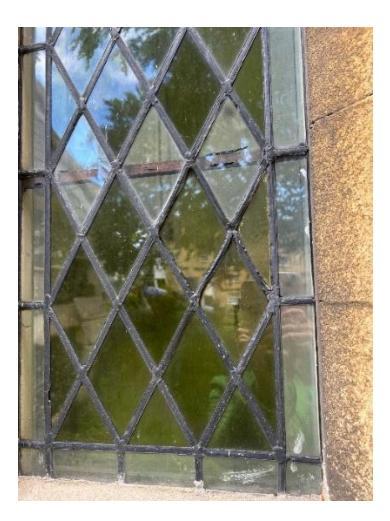
Above – Close up of Window 2

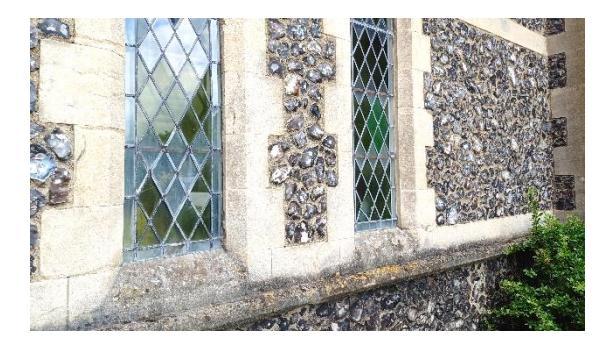
Windows 4 and 5

Some time earlier this year it was noticed that two of the office windows (marked 4 and 5 on the church plan) had either had holes punched in them or been hit by an object, probably deliberately. This was reported to the Police and a crime number obtained. It was decided not to pursue a claim through the insurance company.

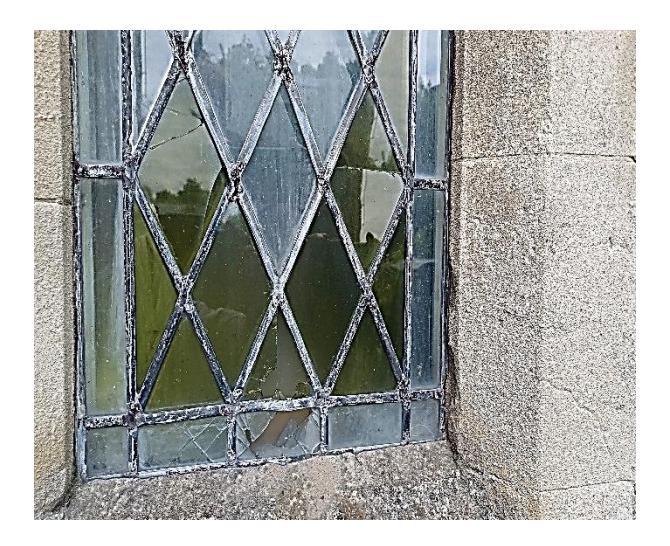
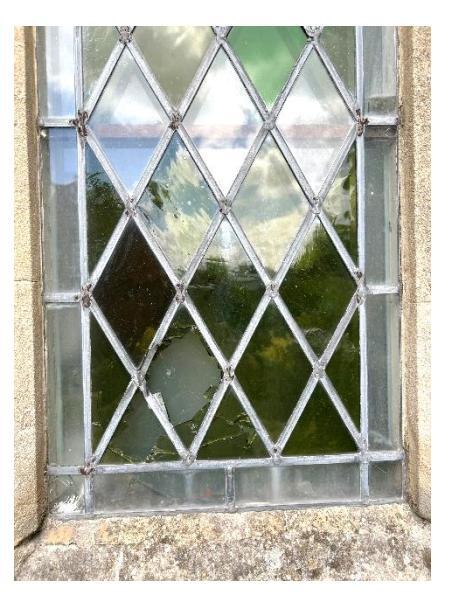
Above and below – Window 4 showing broken panes and worn leadwork. The lower section 14"x48" to be removed, releaded and reglazed.

Remove, re-lead and reglaze one lower section panel 48 x 14 inches. £970.00

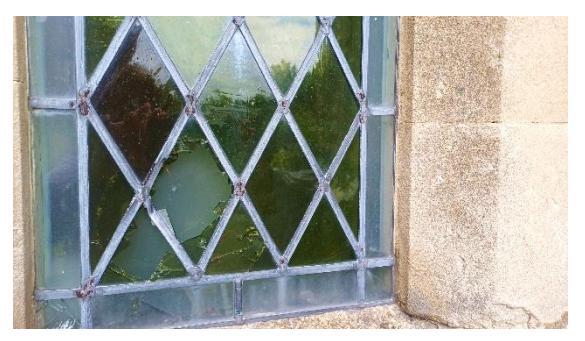
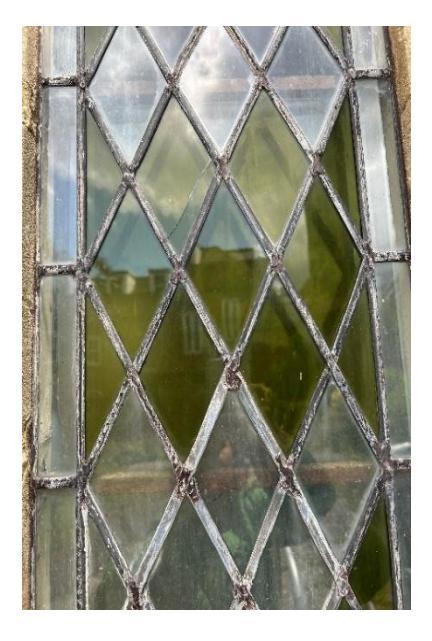
Above two photos – Window 5 showing broken panes, to be replaced.

Replace on site 10 damaged quarries of glass in existing leaded lights. £495.00
